Manhole Inspection Summary

Manhole # S33E__005MH

Insp Date: **11/11/08 1:44 PM**

Location Address: **8 w saratoga st**

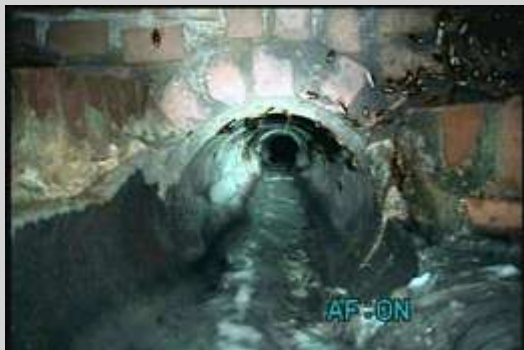
12 O'Clock Outflow

10 in. Circular Gravity Sewer
Pipe Out @ 12 OClock

Pipe Material: **Clay** ☐ Pipe Lined

Invert Depth: **18.41** (ft.) Flow Characteristics: **Fast**

Deposits: ☒ None ☐ Mud ☐ Sludge ☐ Debris ☐ Grease

Infiltration: **None** Pipe Seal Cond: **Unknown**

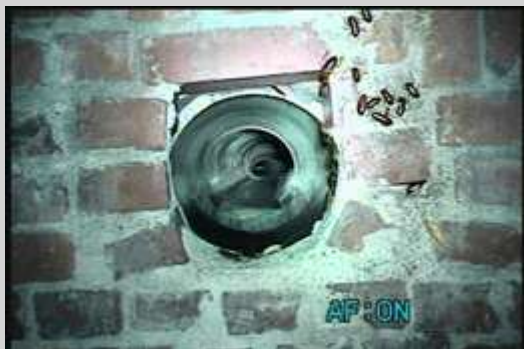
3 O'Clock Inflow

8 in. Circular Gravity Sewer
Pipe In @ 3 OClock

Pipe Material: **Clay** ☐ Pipe Lined

Invert Depth: **14.30** (ft.) Flow Characteristics: **Fast**

Deposits: ☒ None ☐ Mud ☐ Sludge ☐ Debris ☐ Grease

Infiltration: **None** Pipe Seal Cond: **Unknown**

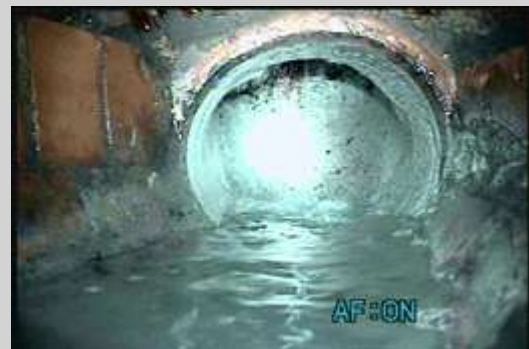
Drop In @ 3 OClock

Drop: **Outside Direct**

Inv Depth: **18.25** (ft.)

Drop Condition: **Open**

Connects To: **House connection / Service line**

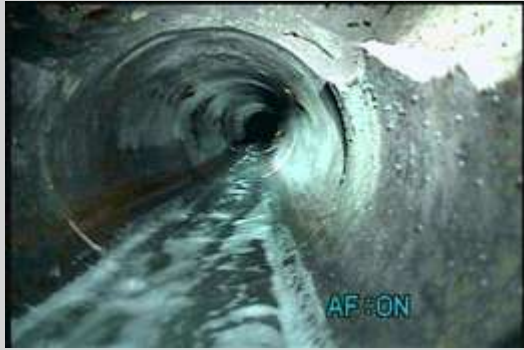
6 O'Clock Inflow

10 in. Circular Gravity Sewer
Pipe In @ 6 O'Clock

Pipe Material: **Clay** ☐ Pipe Lined

Infiltration: **None** Pipe Seal Cond: **Unknown**
